Asbestos and disasters - example of a country in transition

B. Zoraja¹, Z. Mirosavljevic¹, B. Tot¹, S. Vujovic¹

¹ Department of Environmental Protection Engineering and Occupational Safety, Faculty of Technical Sciences,
University of Novi Sad, Novi Sad, Serbia

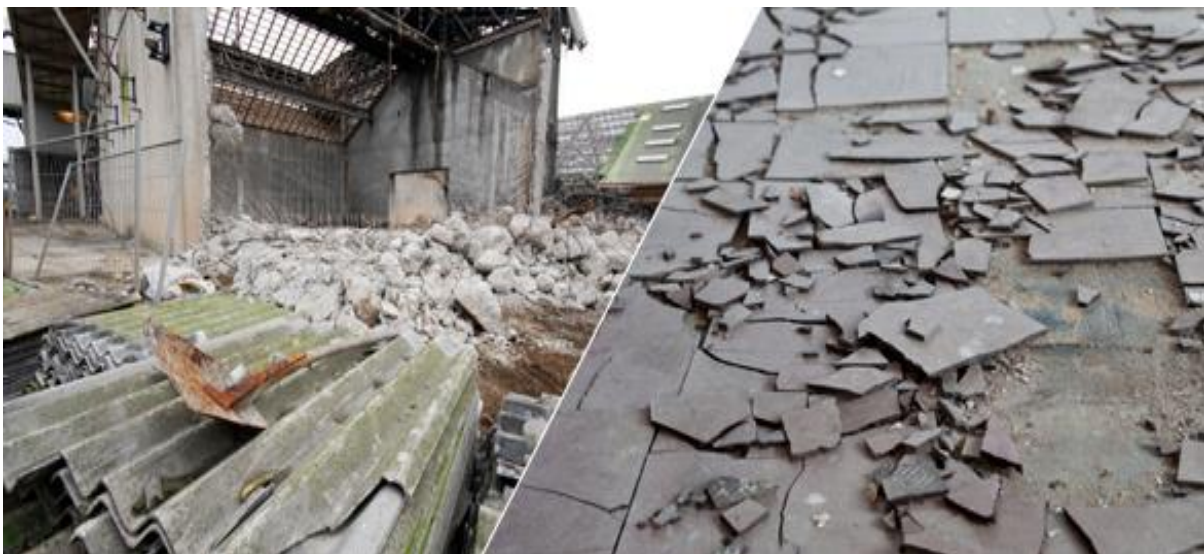
Figure 1. Asbestos in debris [2]

Asbestos is a group of minerals with unique physical and chemical properties. Because of its exceptional properties and affordable price, asbestos was used in over 3,000 products for various purposes around the world. Asbestos materials are characterized by resistance to heat, abrasion and tearing and possess flexibility and a large specific surface area. It is now known that diseases such as asbestosis, lung cancer and mesothelioma can be caused by asbestos, and by establishing this link between disease and asbestos, asbestos has been banned in many countries. In 1983, Iceland was the first country to ban all types of asbestos, currently more than 50 countries have completely banned asbestos, including European Union countries. After the ban on its use and production, asbestos is still found in significant quantities embedded in buildings and products [1]. Danger occurs when these materials are disturbed and when their autonomy is violated, and then asbestos fibers are released. Situations like this especially arise during unforeseen events such as earthquakes, fires, floods, etc. Considering the terrible consequences after the earthquakes in Turkey and Syria, we are again witnessing how much waste remains after such events. This waste often contains asbestos, especially in countries that actively use it. Figure 1 shows an example of asbestos waste generation after a disaster.

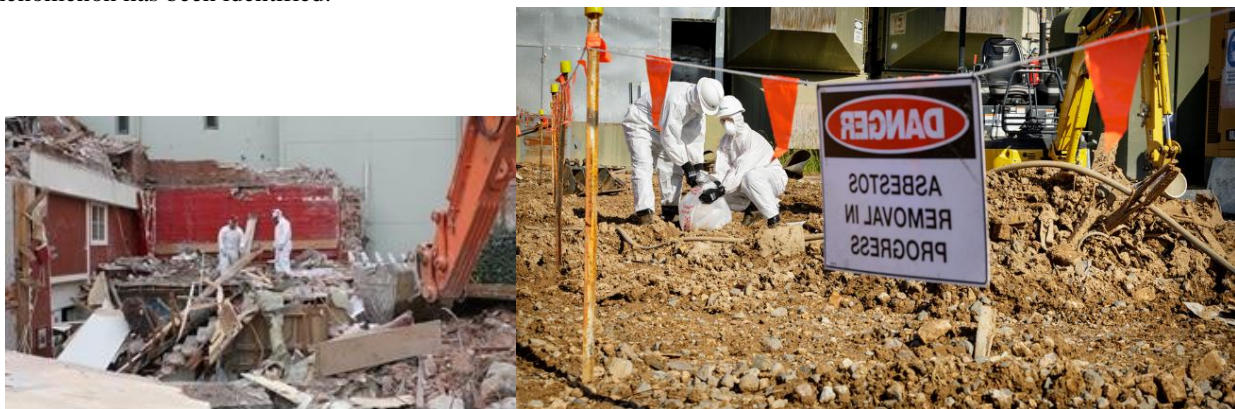
Figure 4 Work on rehabilitation when asbestos is identified [10]

There is no known safe level of exposure to asbestos [1]. Because of this health hazard, it is highly recommended that asbestos-containing material damaged by a disaster be repaired, fenced off, isolated, or removed. Any material containing asbestos must be removed carefully and properly, containerized, and disposed of at a landfill approved to accept this type of waste [9]. Figure 4 shows how the demining work should look like where the asbestos phenomenon has been identified.

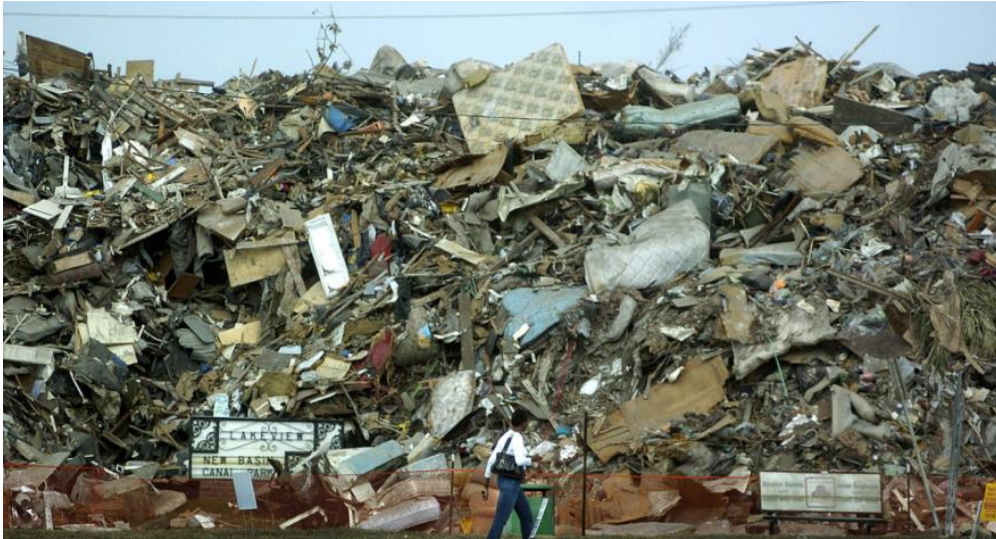
Figure 5 Temporary landfill waste after hurricane Katrina, USA[12]

During the clean-up of damaged and destroyed buildings after an earthquake, it is likely that asbestos-containing materials will be handled, broken up, and disposed of. Much of this work can be undertaken by temporary workers, volunteers and residents who are unfamiliar with the dangers of asbestos and who cannot identify asbestos-containing material. It is unlikely that workers will initially be provided with appropriate personal protective equipment. Many will also be unaware of methods for proper cleaning and removal of asbestos materials. As a result of clean-up operations, there may be an accumulation of asbestos-containing waste that will pose a hazard to people in the local environment and those living in the immediate vicinity of the final disposal site. Figure 5 shows a temporary landfill created from the debris after Hurricane Katrina in 2005.
