Relationship Between Phytoplankton Composition and Bacterial Load Dynamics in Buyukcekmece Dam Lake (Istanbul, Turkey), a Drinking Water Resource

Nese Yilmaz^{*1}, Cumhuriyet Yardimci², Remziye Eda Yardimci³ and Mohamed Elhag⁴

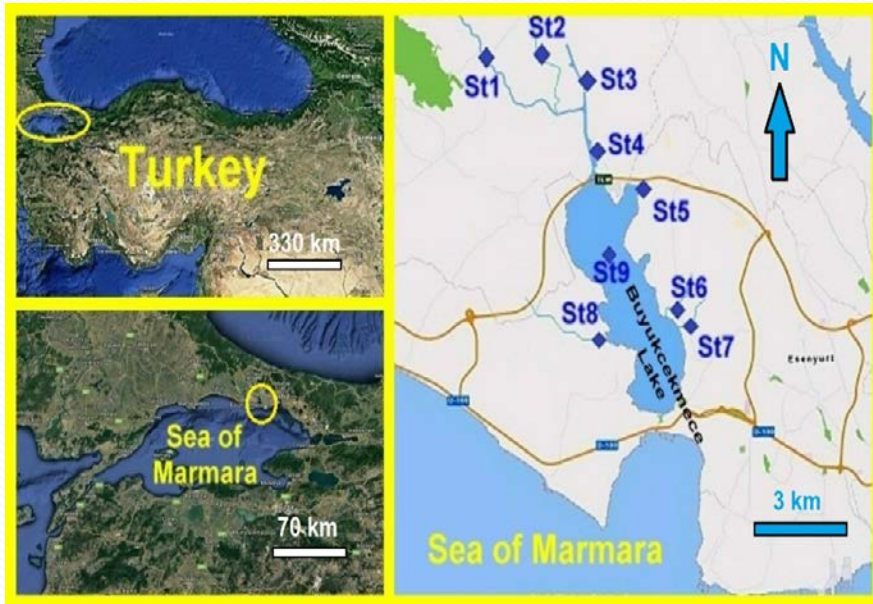
Figure 1. Map of Buyukcekmece Dam Lake

- Sampling was carried out between May 2017 and February 2018 from 9 sampling stations (Fig. 1 and Tab. 1).

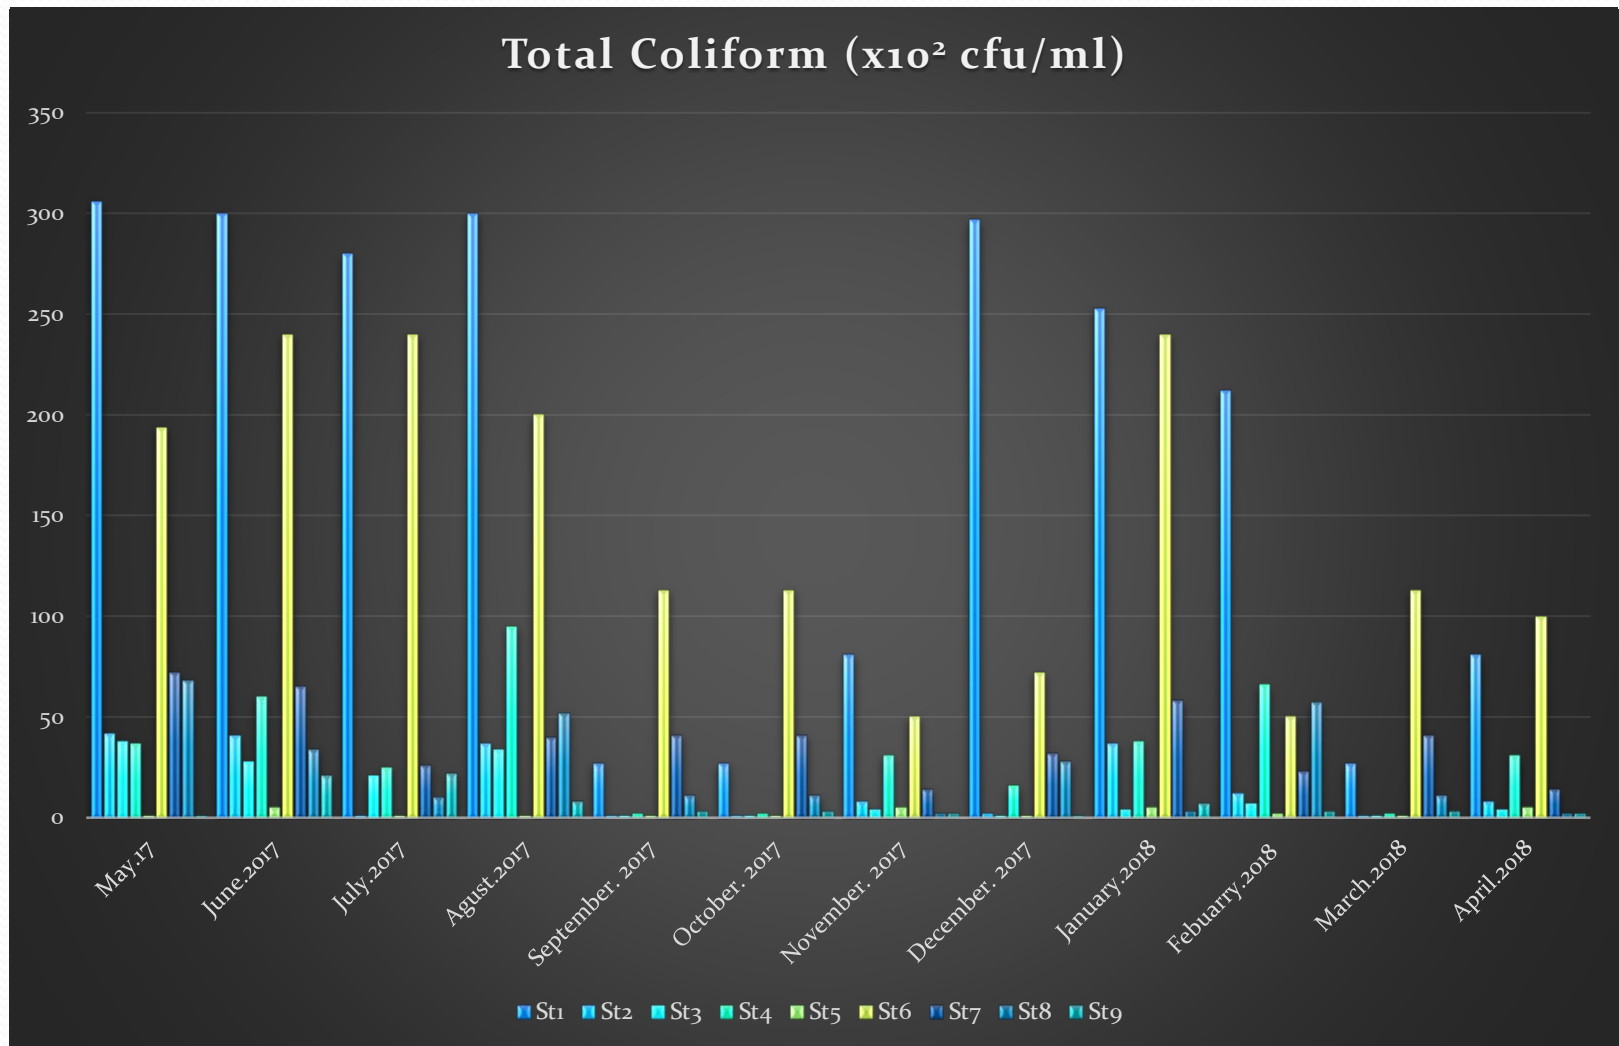
Figure 2. Total coliform bacteria load according sampling stations.

- Phytoplankton community of Buyukcekmece Dam Lake and its influent streams, constituted of 63 taxa belonging to 8 divisions: Bacillariophyta (22), Charophyta (6), Chlorophyta (14), Cryptophyta (2), Cyanobacteria (8), Euglenozoa (8) Miozoa (2) and Ochrophyta (1) (Yilmaz, 2019).
- If the stations were compared according to the number of species diversity, the richest have detected respectively as Eskice Stream (St. 3), Buyukcekmece Lake (St. 9), Karasu (St. 1), Beylikçayı (St. 5), Tahtaköprü (St. 8), İzzettin (St. 2), Ahlat (St. 4), Çekmece (St. 6) and Çakmaklı (St. 7) streams.
- Minimum and maximum load of total heterotrophic aerobic bacteria, total and fecal coliform were determined as 1×10^2 - 1330×10^2 , 1×10^2 - 378×10^2 and 9×10^2 - 551×10^2 cfu/ml respectively (Figures 2-4).
